**CRS No. A-00005**

Name: Dwelling, 171 Bowers Beach Road

1. HISTORIC NAME/FUNCTION: Dwelling, 171 Bowers Beach Road
2. ADDRESS/LOCATION: 171 Bowers Beach Road
3. TOWN/NEAREST TOWN: Little Heaven vicinity? ☒
4. MAIN TYPE OF RESOURCE:      building ☒      structure ☐      site ☐      object ☐  
   landscape ☐      district ☐
5. MAIN FUNCTION OF PROPERTY: Residential
6. PROJECT TITLE/ REASON FOR SURVEY (if applicable):  
SR1, Little Heaven Grade Separated Intersection Improvements

CULTURAL RESOURCE SURVEY  
MAIN BUILDING FORM

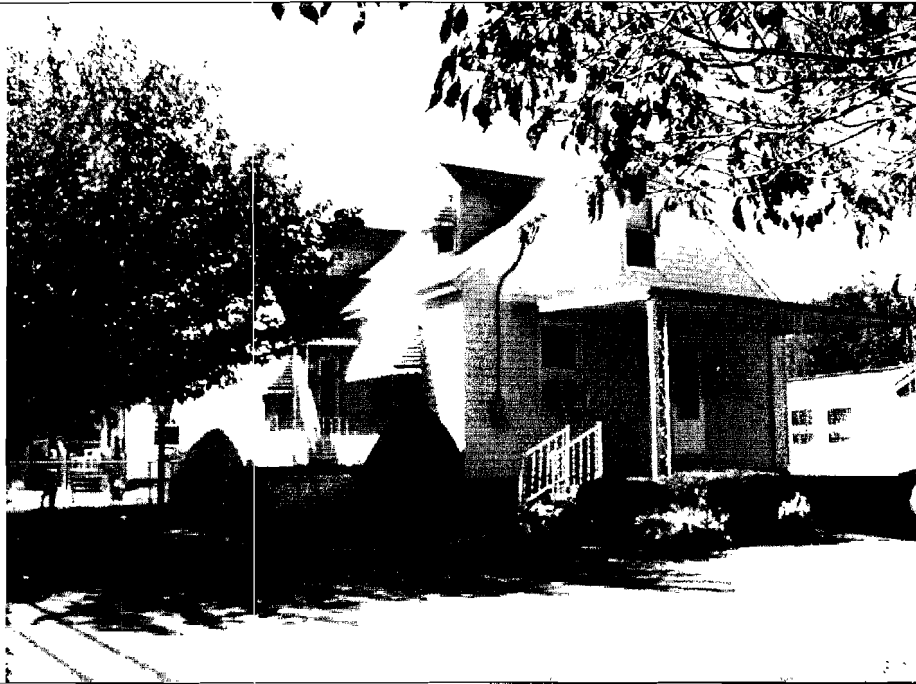
A-00005. Photograph 1: Dwelling, south and east elevations, view looking northwest. This dwelling was constructed by the current property owner's father in 1951.

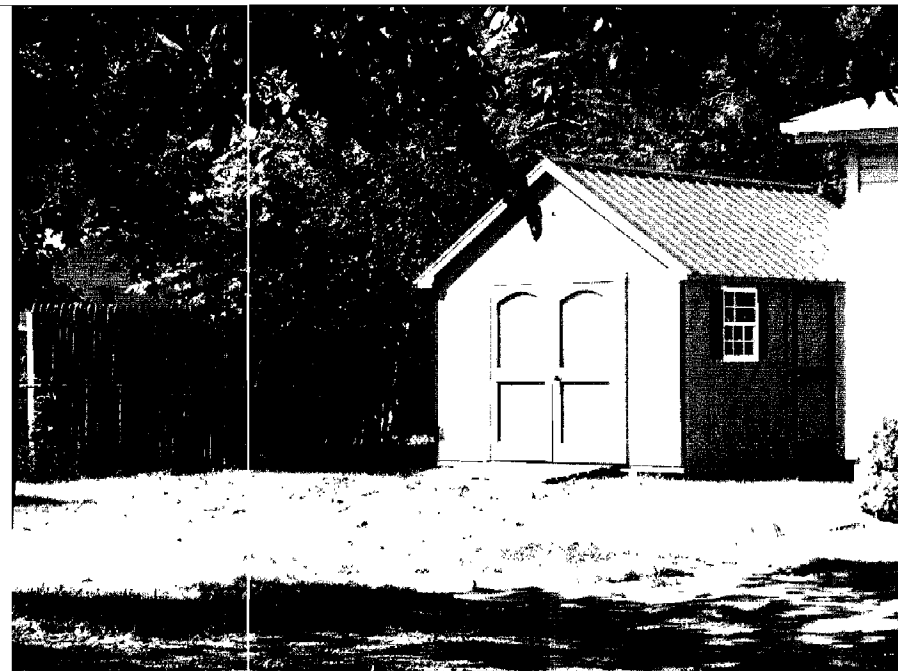
A-00005. Photograph 6: Modern shed, south and east elevations, looking northwest. This prefabricated shed is located to the west of the modern dwelling.
